Ref: HBA/NE//NT/1769

**Update from findings started on Friday, 11 March
with the full exposure of the base perimeter timber frame
supporting the lantern's cast iron frame legs.
Inc. 17 March assessed with
costed outcomes, P-8**

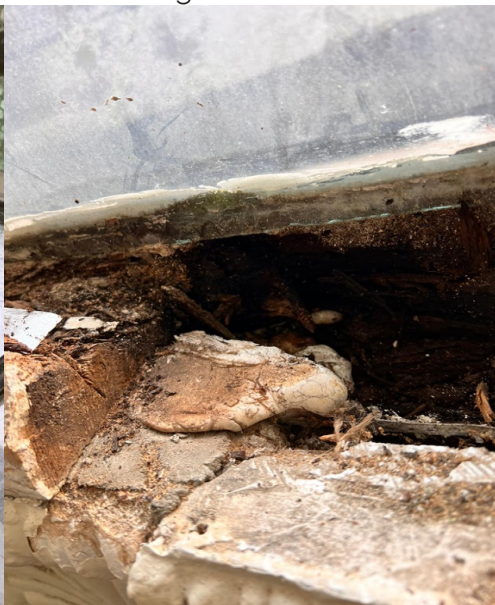
Photo 2 rotting out and silicone "blob"

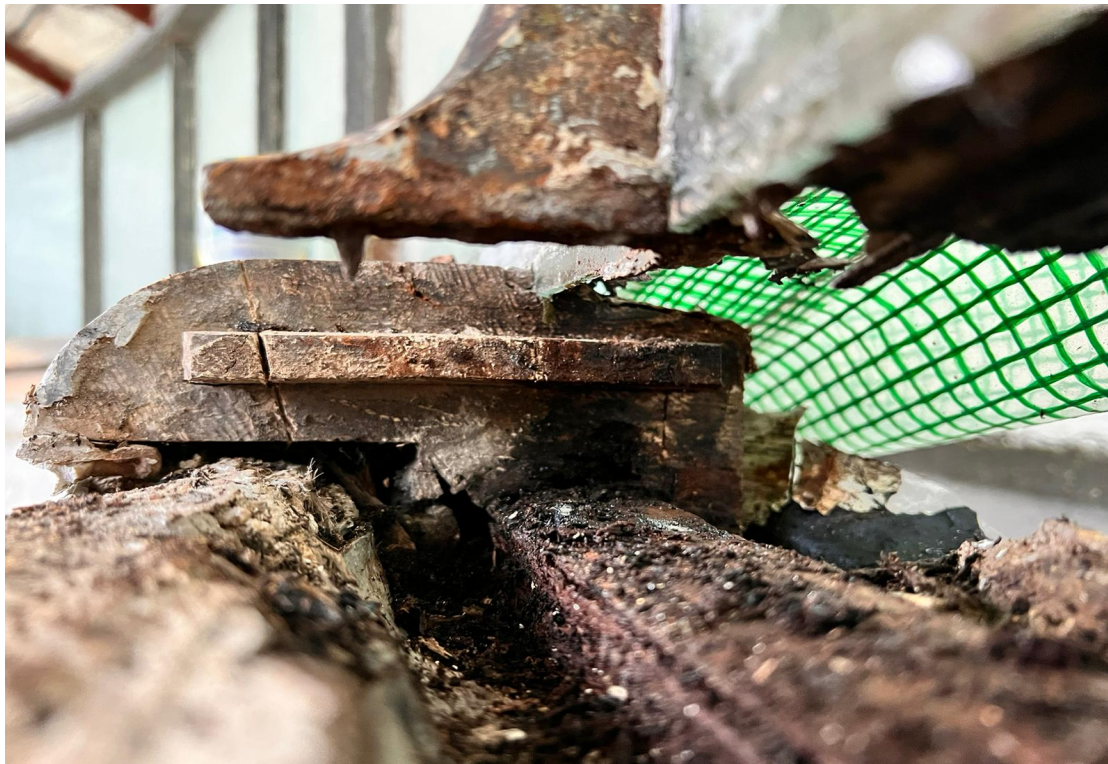
Photo 3

Photos 3 & 4 demonstrate scale of rot out beneath the feet of the lantern frame.

Note the biscuit tongue and rotted sill nosing to the right of pic.

The iron bar has rusted out, inc. the screws of both the foot of leg, all saturated.

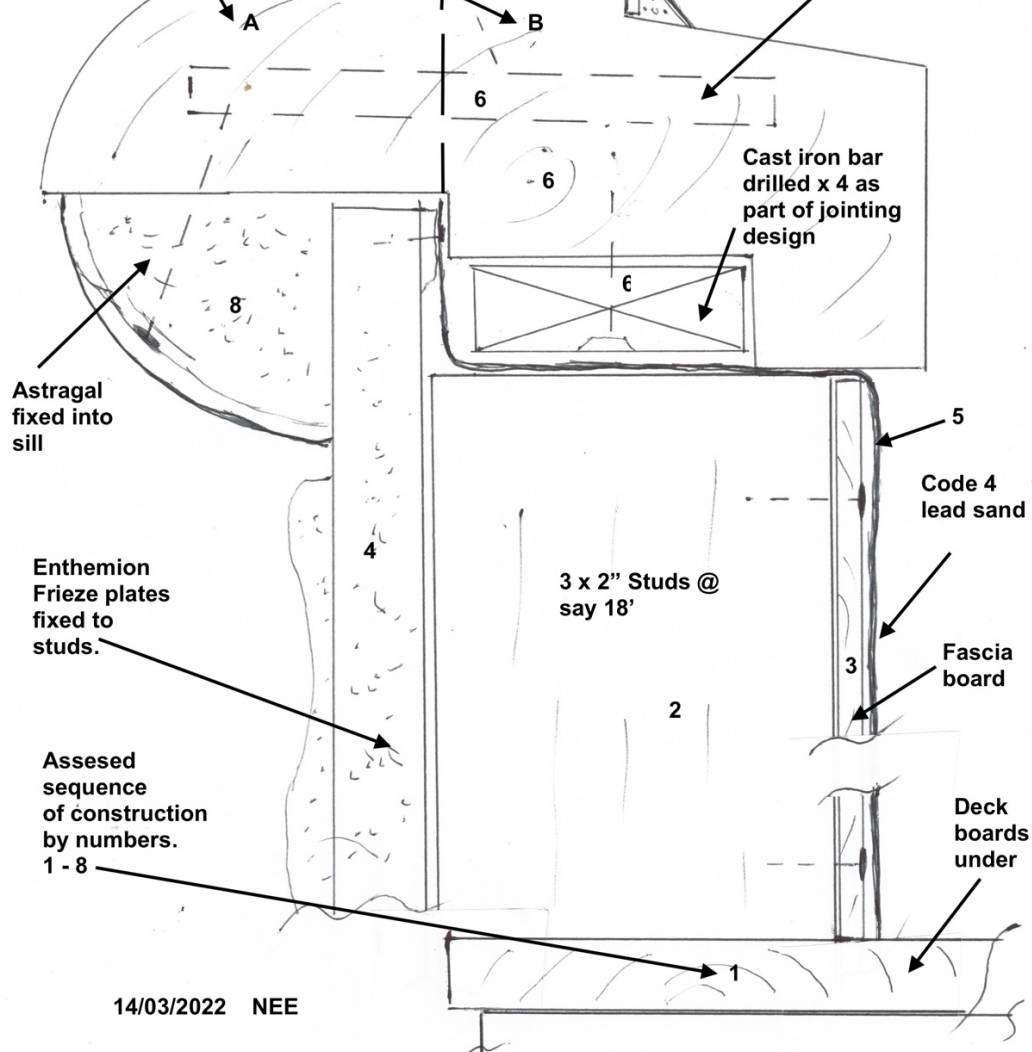
32 Sussex Sq Lantern base in section. Scale 1 - 1 @ A4

Pitch pine section designed to be resting sole plate for lantern G bars into inc weathering detail S/plate curved to follow ellipse in 7 pieces @ approx 50" each.

The requirement to replace as all rotted will involve remaking as 2 pieces A & B due to complexity of fitting into. A from int B from ext

resin glued and screwed

The new base timbers, when made to original pattern and curve will need to be of two split components, pre-faced to fit against each other. This will allow the inside round nosed section to be fed into place, cutting in the heel trenching as going to re-engage the uprights, wedged up into place to re-load the lantern. The external sill section can then be fed in against the RN sect and glued with high impact resin, then clamped together. Jointing biscuits can be fed into pre-cut mortices, made open at the external face, resin glued and screwed down into with brass screws as fitting proceeds. The proposed process negates the need for disturbing the lantern frame at all.

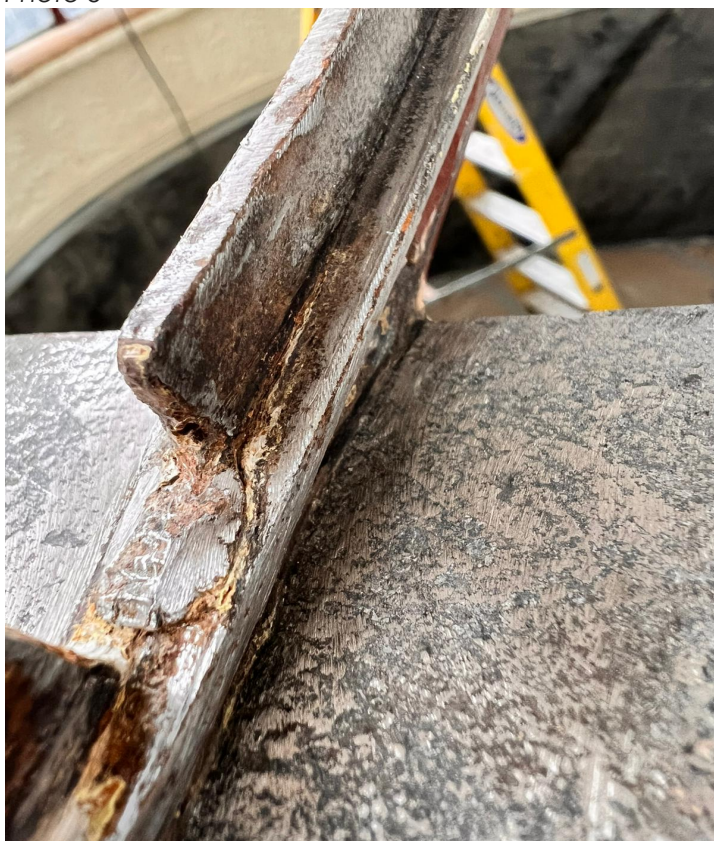
Photo 5

Note: The work was originally carried out as a progressive element stacking with the lantern being formed up from a precast kit of parts. All held/braced in place with peg ended tops of the uprights fed through the “ring” and the radial G/bars then peened over to lock all into place. Note missing G/bar section to facilitate.

We cannot disturb this “riveted” cast iron frame. So an ideal was agreed as to a **Methodology to restore**.

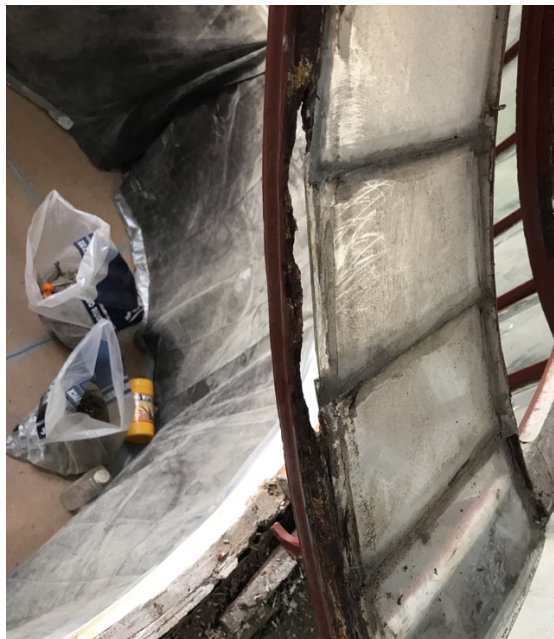
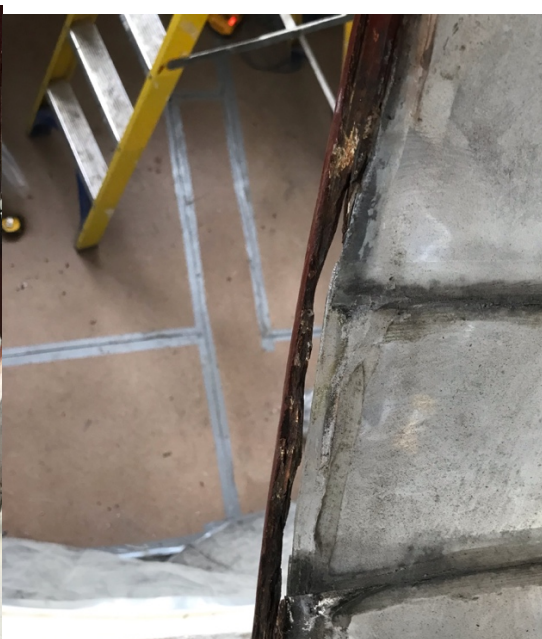
The cast iron frame is a work of great skill and art. We must take comfort from the knowledge that it has remained essentially intact, in spite of the many attempts at maintenance. However, there is loss through rust out of at least 3 of the spokes at the lower sections. This was found to be caused mainly from repairs using bathroom silicone as a weathering repair. This entrapped the water beneath it.

Note: none of the losses are total and integrity remains sufficient to grant a repair.

Fortunately, there is a repair strategy available to us utilizing a product called J B weld this can be used to reform the lost G/bar edging.

Have a pattern made to reform a new curved glazing bar from 3 mm steel. Worked and fitted into place with a 2-pack resin (J B Weld system) grinder massaged into the original form. [As at 14 March]
